**Flood Control Project Maintenance
Levee Inspections**

Fall 2016 Levee Maintenance Deficiency Summary Report

Levee Inspection Report By Mile - Fall 2016

Waterway	Bank	Unit Miles	Inspection Start/End	Inspector
Unit No. 01 Right Bank Cache Creek	Right	0.59	10/07/2016 10/07/2016	Oleg Yakimov

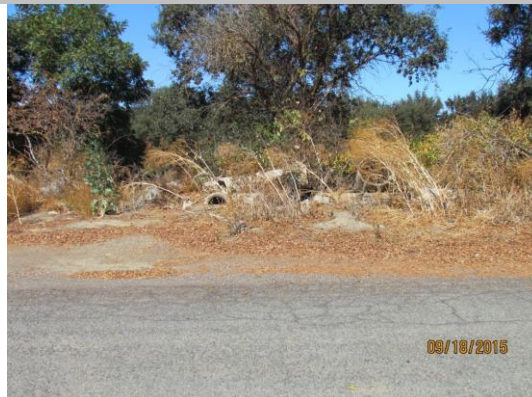
Photo 1 of 1 : FA_2016_NA0021_351_15_20160913_00013.jpg

LM Start	0.03	Rating **	M	Issue No.	15
LM End	0.03	Issue Type +	Ma	Location *	WS
Category	Earthen Levee			GPS Latitude/Longitude	
				Start	End
Item	Encroachments			38.720895 °	38.720895 °
				-121.810408 °	-121.810408 °
DWR ID	DWR_NA0021_01_f_2015_15				
Comment Code					
DE : Debris					
Inspector Comment

View of the debris on the waterward side of the levee. Fall 2015.

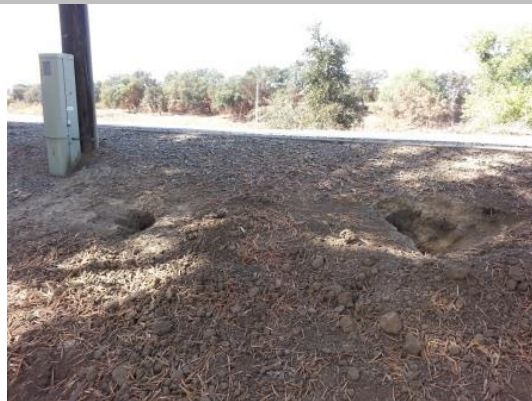
Photo 1 of 3 : FA_2016_NA0021_351_16_20161010_00024.jpg

LM Start	0.19	Rating **	U	Issue No.	16
LM End	0.19	Issue Type +	Ma	Location *	LS
Category	Earthen Levee			GPS Latitude/Longitude	
				Start	End
Item	Animal Control			38.721536 °	38.721536 °
				-121.807711 °	-121.807711 °
DWR ID	DWR_NA0021_01_s_2015_16				
Comment Code					
A3 : No rodents visible, but rodent burrows visible; need to backfill and compact or grout burrows.					
Inspector Comment

An updated view of rodent holes on LS slope. Fall inspection 10/07/2016.

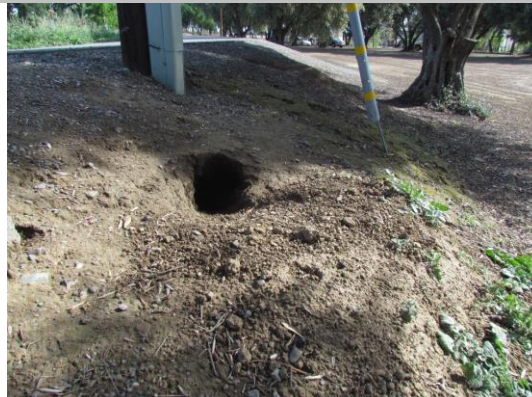
Photo 2 of 3 : FA_2016_NA0021_351_16_20160913_00014.jpg

View of the rodent hole on the landward side of the levee looking downstream. Spring 2015.

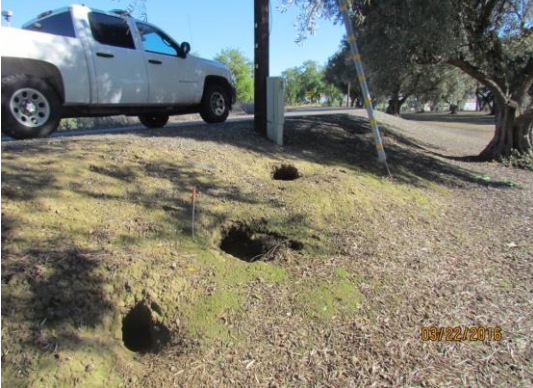
Photo 3 of 3 : FA_2016_NA0021_351_16_20160913_00015.jpg

View of the rodent holes on the landward side of the levee looking downstream. Spring 2016.

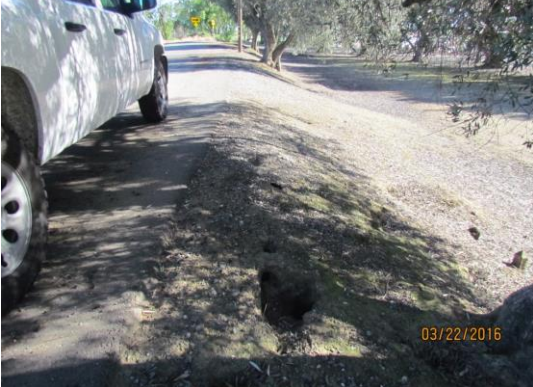
Photo 1 of 2 : FA_2016_NA0021_351_7_20160913_00005.jpg

Perspective view of the rodent hole on the landward side of the levee looking downstream. Spring 2016.

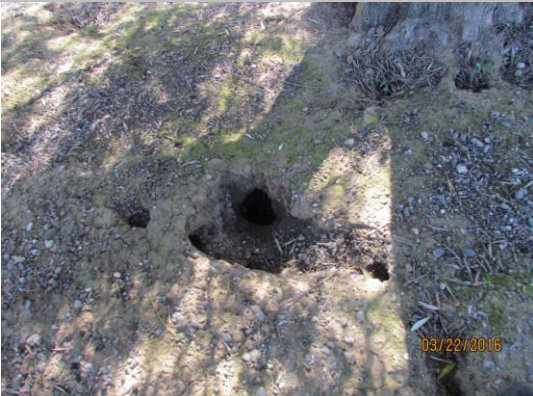
Photo 2 of 2 : FA_2016_NA0021_351_7_20160913_00006.jpg

Animal hole is close to the shoulder of the levee. Spring 2016.

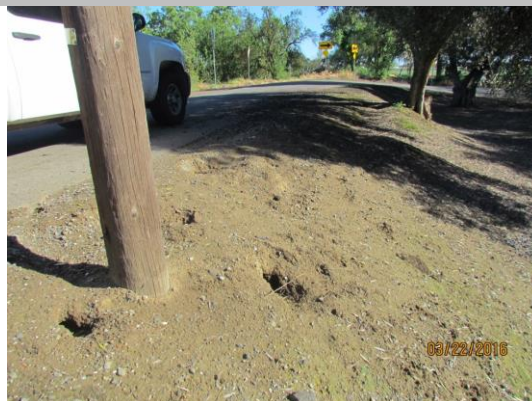
Photo 1 of 1 : FA_2016_NA0021_351_8_20160913_00007.jpg

LM Start	0.22	Rating **	U	Issue No.	8
LM End	0.22	Issue Type +	Ma	Location *	LS
Category	Earthen Levee			GPS Latitude/Longitude	
				Start	End
Item	Animal Control			38.721876 °	38.721876 °
				-121.807393 °	-121.807393 °
DWR ID	DWR_NA0021_01_s_2016_8				
Comment Code					
A3 : No rodents visible, but rodent burrows visible; need to backfill and compact or grout burrows.					
Inspector Comment

View of the rodent holes on the landward side of the levee looking downstream. Spring 2016.

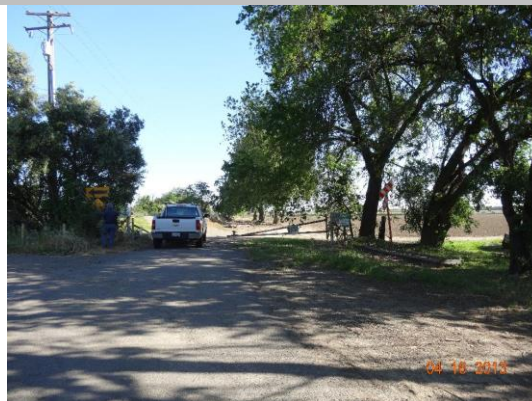
Photo 1 of 2 : UCIP_FA_2016_39855_69553.jpg

LM Start	0.24	Rating **	M	Issue No.	23
LM End	0.24	Issue Type +	En	Location *	LS
Category	Supplemental			GPS Latitude/Longitude	
				Start	End
Item	DWR UCIP Field Study			38.722162 °	38.722162 °
				-121.807223 °	-121.807223 °
DWR ID					
Comment Code					
Inspector Comment					
FS_ID:39855 DS_ID:19554 EP_NO: 6790 Repair Type: Non-Urgent Crossing Status: Indicator Found UCIP Comments: Need to contact owner to determine if crossing is still active and to determine last inspection date. Will need copy of letter showing crossings passed inspection. FIELD_STRUCT_DESC: 6-inch gas line through levee, 4-feet below the crown. Pipe extends from borrow area and under the channel. Bleeder valve on waterward bank. Service vault located on landward side next to access gate. Paved access ramp on landward slope. (Permit No. 6790-1970) FS Date: 4/16/2013

View of landward side near access gate. Gas line marker located on between trees. Line runs parallel to access roadway and through levee.

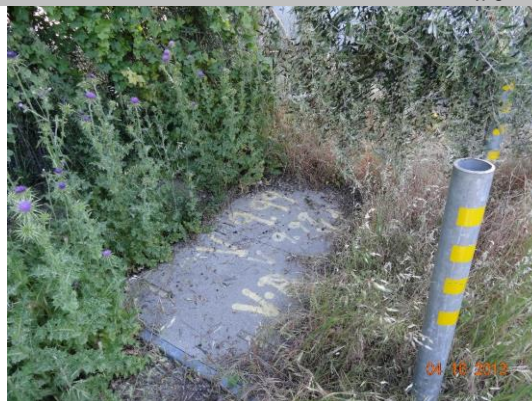
Photo 2 of 2 : UCIP_FA_2016_39855_69554.jpg

Comment Code						
Inspector Comment						
FS_ID:39855						
DS_ID:19554						
EP_NO: 6790						
Repair Type: Non-Urgent						
Crossing Status: Indicator Found						
UCIP Comments: Need to contact owner to determine if crossing is still active and to determine last inspection date. Will need copy of letter showing crossings passed inspection.						
FIELD_STRUCT_DESC: 6-inch gas line through levee, 4-feet below the crown. Pipe extends from borrow area and under the channel. Bleeder valve on waterward bank. Service vault located on landward side next to access gate. Paved access ramp on landward slope. (Permit No. 6790-1970)						
FS Date: 4/16/2013

Service vault located on landward toe near gate access gate.

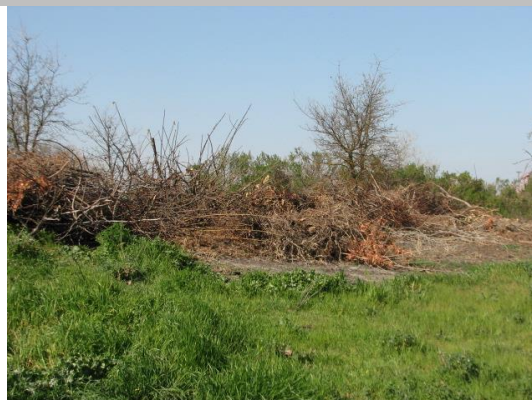
Photo 1 of 3 : FA_2016_NA0021_351_4_20160913_00001.jpg

LM Start	0.26	Rating **	M	Issue No.	4
LM End	0.26	Issue Type +	Ma	Location *	WS
Category	Earthen Levee			GPS Latitude/Longitude	
				Start	End
Item	Encroachments			38.722418 °	38.722418 °
				-121.806999 °	-121.806999 °
DWR ID	DWR_NA0021_01_s_2012_4				
Comment Code					
PR : Prunings					
Inspector Comment

A continuous brush pile on levee. Spring 2013

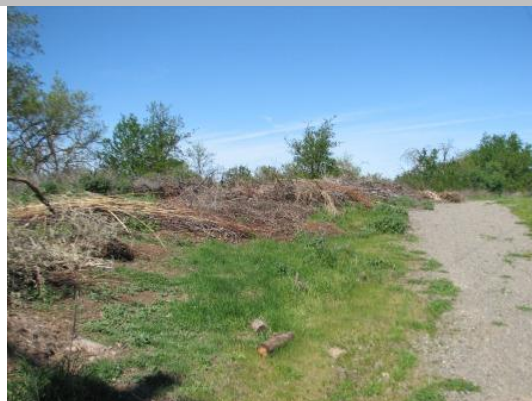
Photo 2 of 3 : FA_2016_NA0021_351_4_20160913_00002.jpg

The brush pile did not get burned this last winter. Spring 2014

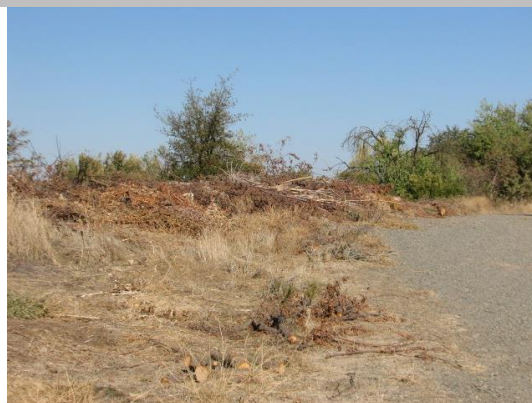
Photo 3 of 3 : FA_2016_NA0021_351_4_20160913_00003.jpg

The latest look of the ongoing brush pile. Fall 2013

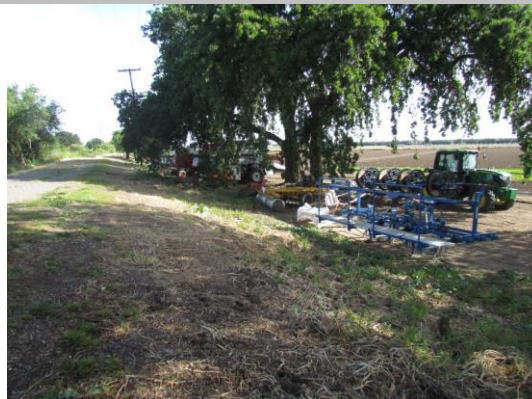
Photo 2 of 3 : FA_2016_NA0021_351_18_20160913_00017.jpg

View of equipment on the landward side of the levee looking downstream. Spring 2015.

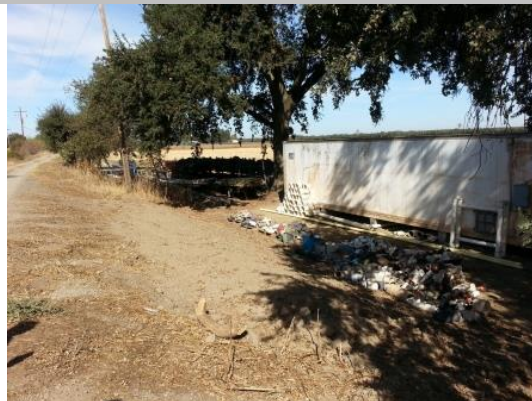
Photo 3 of 3 : FA_2016_NA0021_351_18_20161010_00026.jpg

LM Start	0.27	Rating **	M	Issue No.	18 (cont)	
LM End	0.27	Issue Type +	En	Location *	LS	
Category	Earthen Levee			GPS Latitude/Longitude		
				Start		End
Item	Encroachments			38.722615 °		38.722615 °
				-121.806952 °		-121.806952 °
DWR ID	DWR_NA0021_01_s_ 2015_18					
Comment Code						
EQ : Equipment						
Inspector Comment

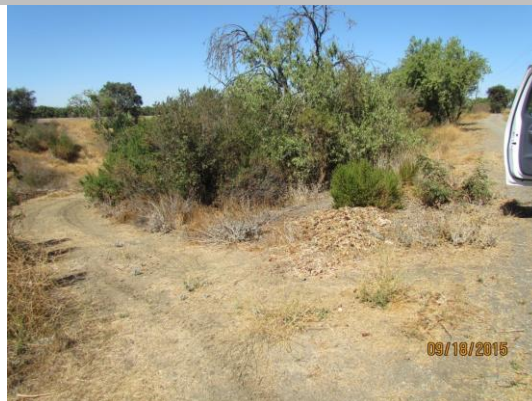
Photo 1 of 3 : FA_2016_NA0021_351_22_20160913_00018.jpg

LM Start	0.27	Rating **	M	Issue No.	22
LM End	0.27	Issue Type +	Ma	Location *	WS
Category	Earthen Levee			GPS Latitude/Longitude	
				Start	End
Item	Slope Stability			38.722620 °	38.722620 °
				-121.806958 °	-121.806958 °
DWR ID	DWR_NA0021_01_f_ 2015_22				
Comment Code					
S3 : Repair the levee slope damaged by vehicle traffic and prevent access where possible.					
Inspector Comment					
A vehicle ramp seems to have been made.

Perspective view of the trail on the waterward side of the levee looking downstream. Fall 2015.

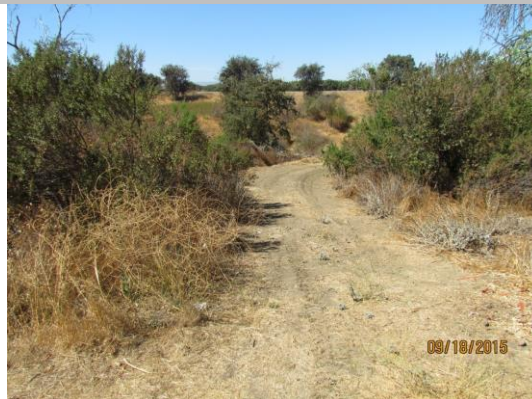
Photo 2 of 3 : FA_2016_NA0021_351_22_20160913_00019.jpg

LM Start	0.27	Rating **	M	Issue No.	22 (cont)	
LM End	0.27	Issue Type +	Ma	Location *	WS	
Category	Earthen Levee			GPS Latitude/Longitude		
				Start		End
Item	Slope Stability			38.722620 °		38.722620 °
				-121.806958 °		-121.806958 °
DWR ID	DWR_NA0021_01_f_2015_22					
Comment Code						
S3 : Repair the levee slope damaged by vehicle traffic and prevent access where possible.						
Inspector Comment						
A vehicle ramp seems to have been made.

View of the trail on the waterward side of the levee. Fall 2015.

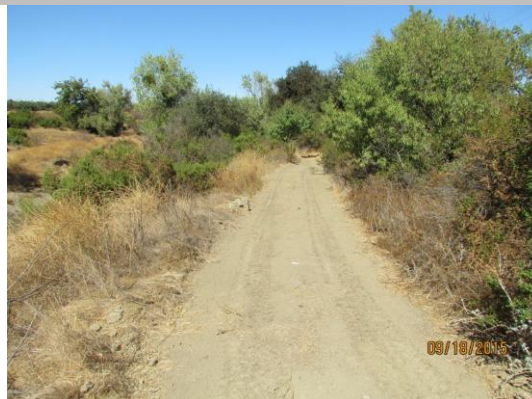
Photo 3 of 3 : FA_2016_NA0021_351_22_20160913_00020.jpg

The trail seems to be an access point that leads down to Cache Creek. Fall 2015.

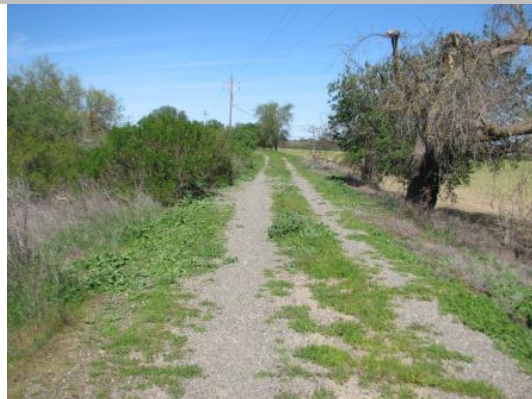
Photo 1 of 1 : FA_2016_NA0021_351_13_20160913_00012.jpg

LM Start	0.30	Rating **	M	Issue No.	13
LM End	0.50	Issue Type +	Ma	Location *	CR
Category	Earthen Levee			GPS Latitude/Longitude	
				Start	End
Item	Vegetation			38.723017 °	38.725844 °
				-121.806879 °	-121.806516 °
DWR ID	DWR_NA0021_01_s_2014_13				
Comment Code					
V9 : Keep the crown roadway free of vegetation.					
Inspector Comment

Vegetation on the crown needs to be controlled. Spring 2014

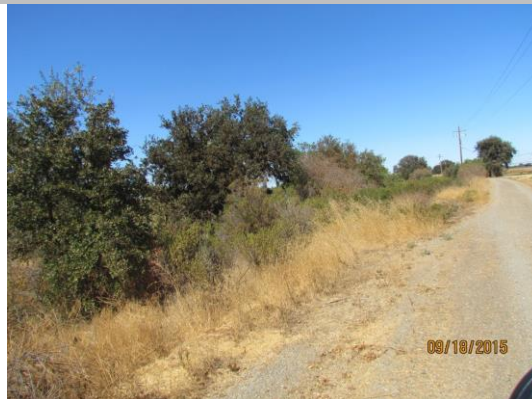
Photo 1 of 1 : FA_2016_NA0021_351_17_20160913_00016.jpg

LM Start	0.30	Rating **	U	Issue No.	17
LM End	0.50	Issue Type +	Ma	Location *	WS
Category	Earthen Levee			GPS Latitude/Longitude	
				Start	End
Item	Vegetation			38.723041 °	38.725887 °
				-121.806877 °	-121.806550 °
DWR ID	DWR_NA0021_01_s_2012_17				
Comment Code					
V2 : Remove the wild growth other than native grasses from the levee slopes.					
Inspector Comment

View of the vegetation on the waterward side of the levee looking downstream. Fall 2015.

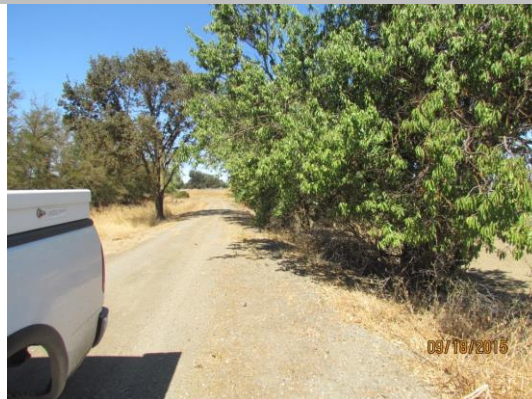
Photo 2 of 2 : FA_2016_NA0021_351_9_20160913_00009.jpg

LM Start	0.44	Rating **	M	Issue No.	9 (cont)	
LM End	0.44	Issue Type +	Ma	Location *	LS	
Category	Earthen Levee			GPS Latitude/Longitude		
				Start		End
Item	Trim / Thin Trees			38.725022 °		38.725022 °
				-121.806478 °		-121.806478 °
DWR ID	DWR_NA0021_01_s_2012_9					
Comment Code						
T1 : Trim trees to at least five feet above ground level.						
Inspector Comment

View of the tree that needs to be trimmed on the landward side of the levee looking downstream. Fall 2015.

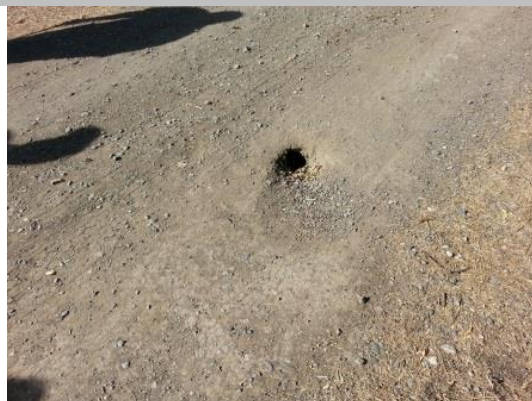
Photo 1 of 1 : FA_2016_NA0021_351_3_20161010_00028.jpg

LM Start	0.44	Rating **	M	Issue No.	3
LM End	0.44	Issue Type +	Ma	Location *	CR
Category	Earthen Levee			GPS Latitude/Longitude	
				Start	End
Item	Animal Control			38.725087 °	38.725087 °
				-121.806502 °	-121.806502 °
DWR ID	DWR_NA0021_01_f_2016_3				
Comment Code					
A3 : No rodents visible, but rodent burrows visible; need to backfill and compact or grout burrows.					
Inspector Comment

Rodent holes on levee crown. No live rodents observed. Fall inspection 10/07/2016.

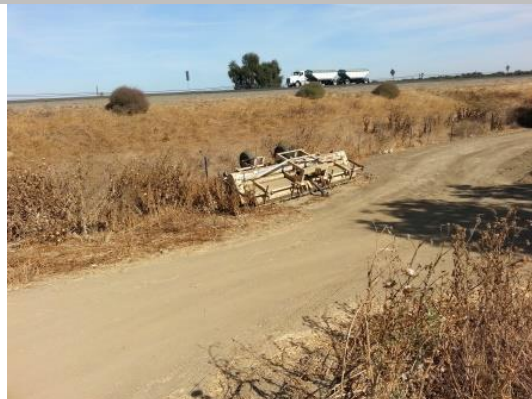
Photo 1 of 1 : FA_2016_NA0021_351_21_20161010_00030.jpg

LM Start	0.49	Rating **	M	Issue No.	21
LM End	0.49	Issue Type +	En	Location *	LS
Category	Earthen Levee			GPS Latitude/Longitude	
				Start	End
Item	Encroachments			38.725722 °	38.725722 °
				-121.806483 °	-121.806483 °
DWR ID	DWR_NA0021_01_f_2016_21				
Comment Code					
EQ : Equipment					
Inspector Comment

Equipment within 10-foot easement of landside toe of the levee. Fall inspection 10/07/2016.
